3RD FLOOR BOILER HOUSE SECTION VII ROOM 7.06 F

**Non-TCRA Building Assessment
Avtex Fibers Superfund Site**

Section/Building:	Section VII 3rd Floor Boiler House	Date & Time: 1/3/00 1030	
Room No./Description:	Room 7.06 F	Field Team: WW, ST, JT

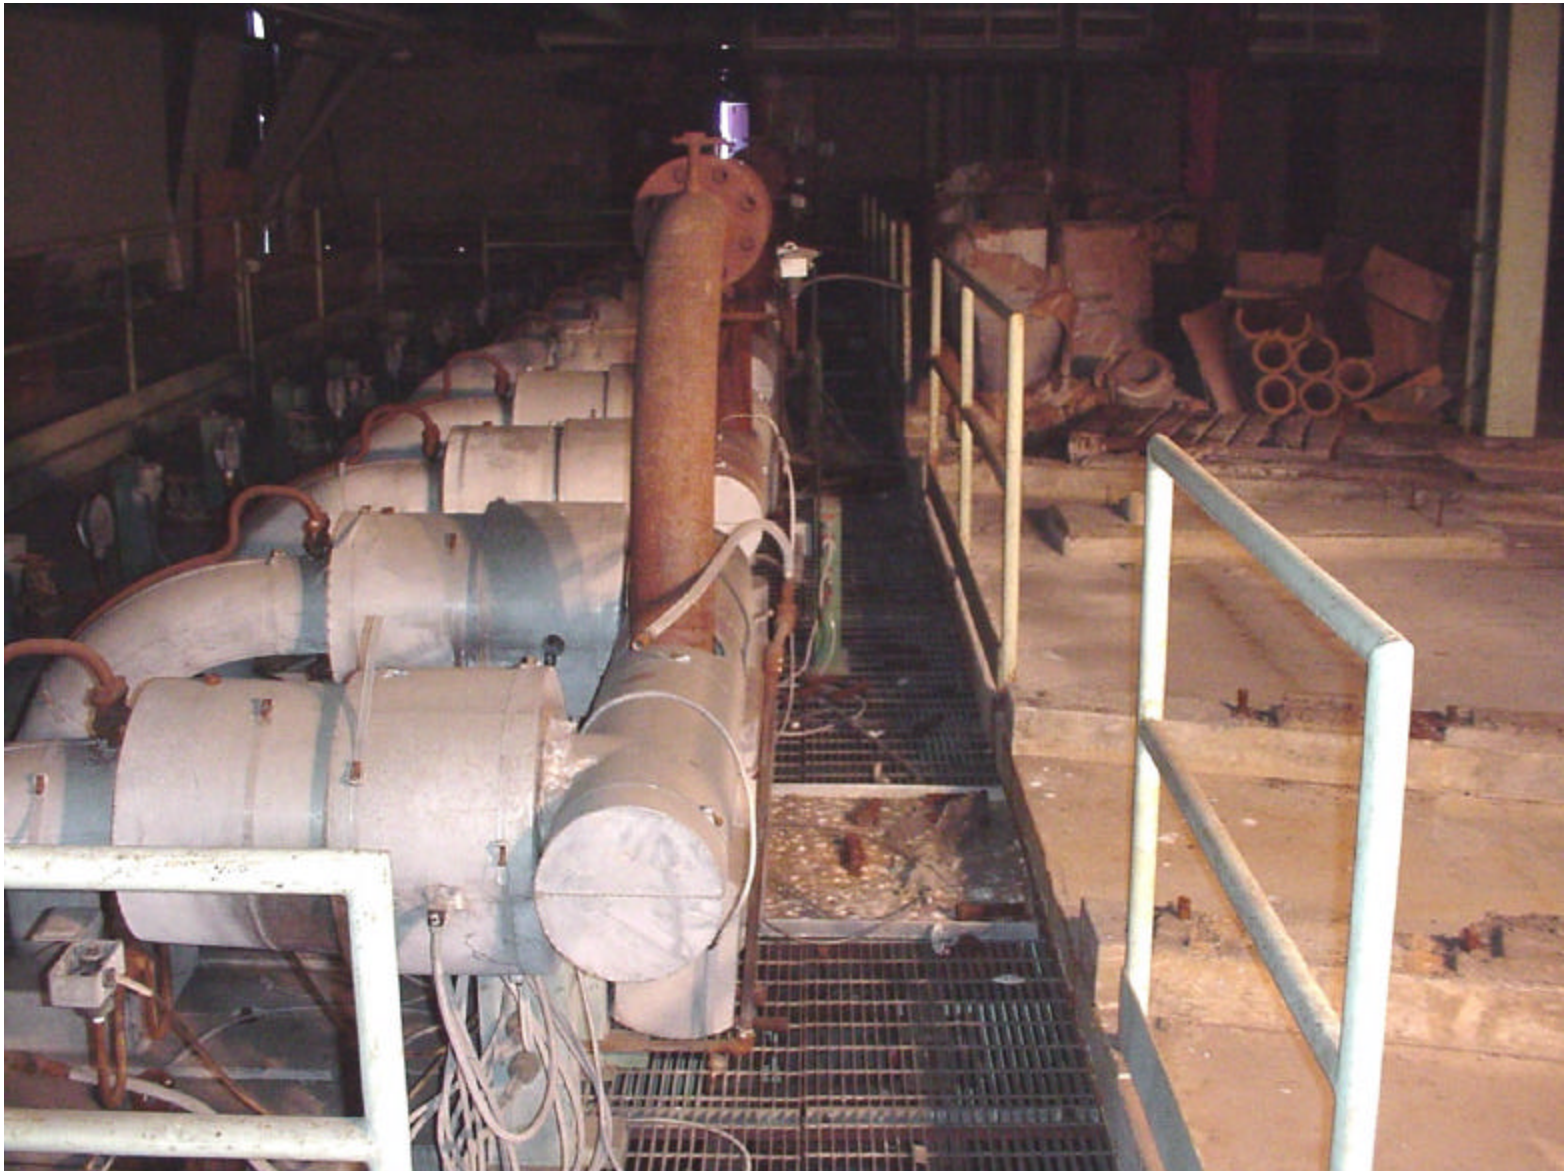
Photograph ID	Date Taken	Section #	Room #	Room Description	Description
MVC-172	11/18/99	I	1.04C	Polyester Spinning 3rd Floor	PACM pipe insulation located throughout room.

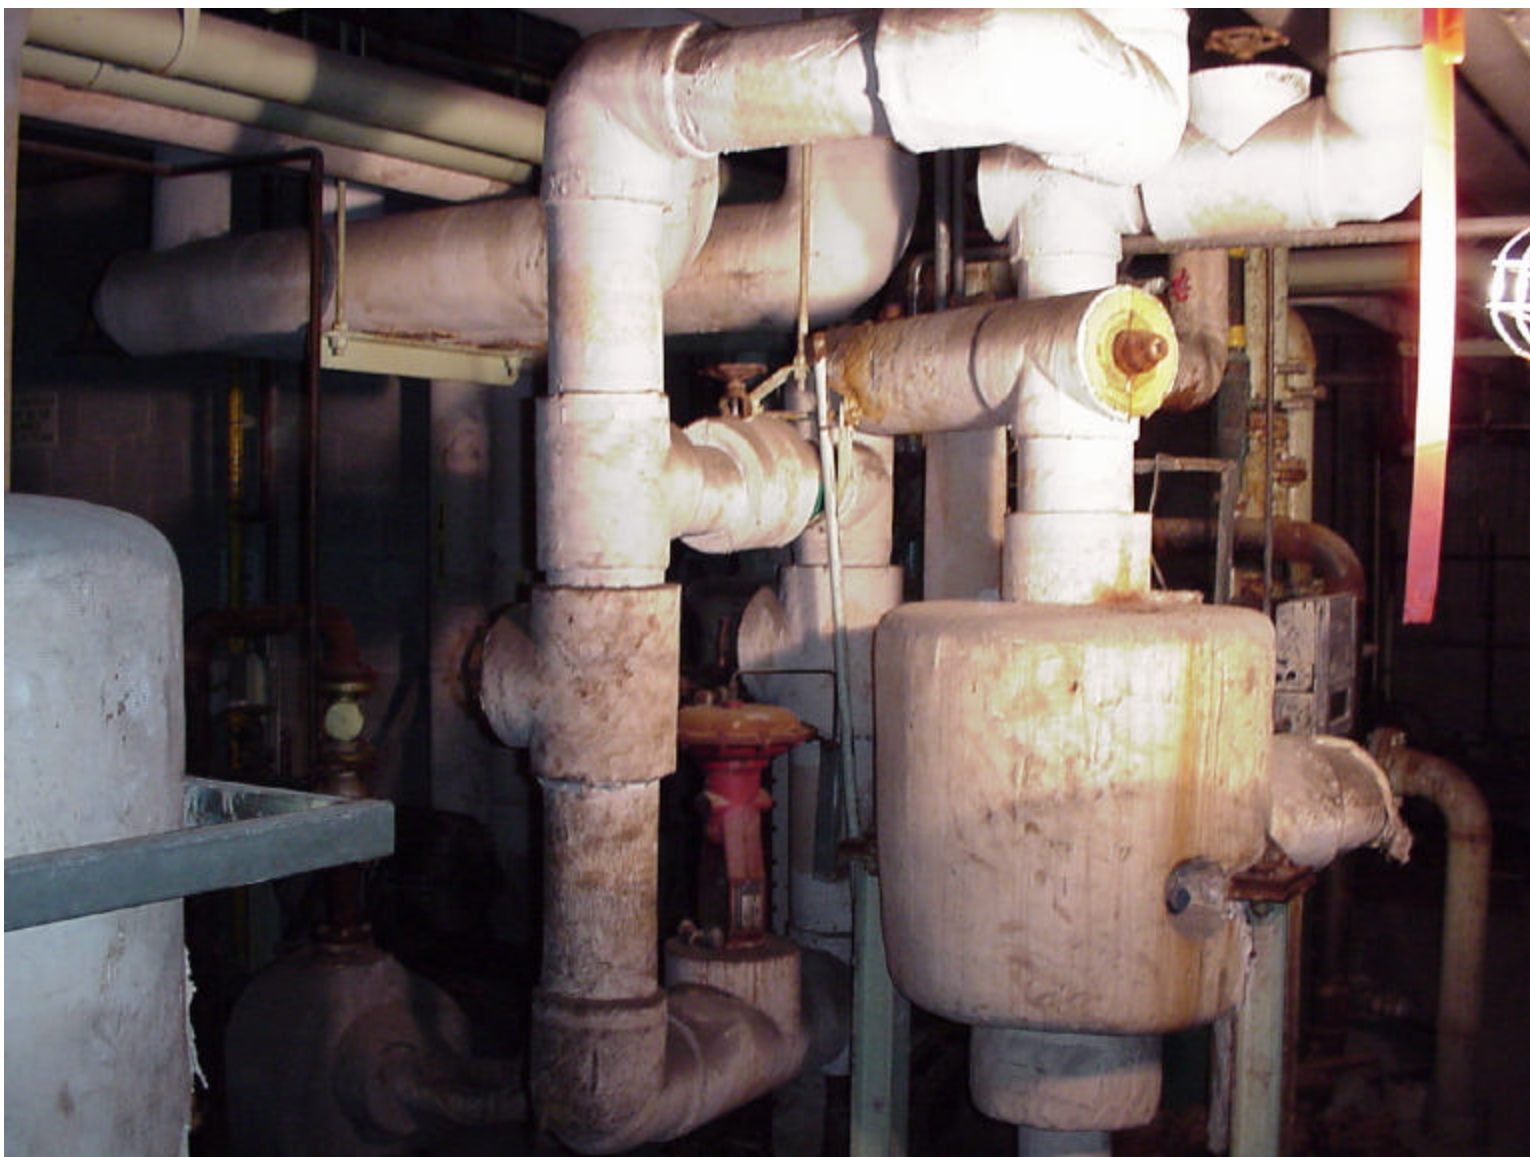
Photograph ID	Date Taken	Section #	Room #	Room Description	Description
MVC-174	11/18/99	I	1.05D	Polymer Plant 3rd Floor	PACM pipe insulation located throughout room.

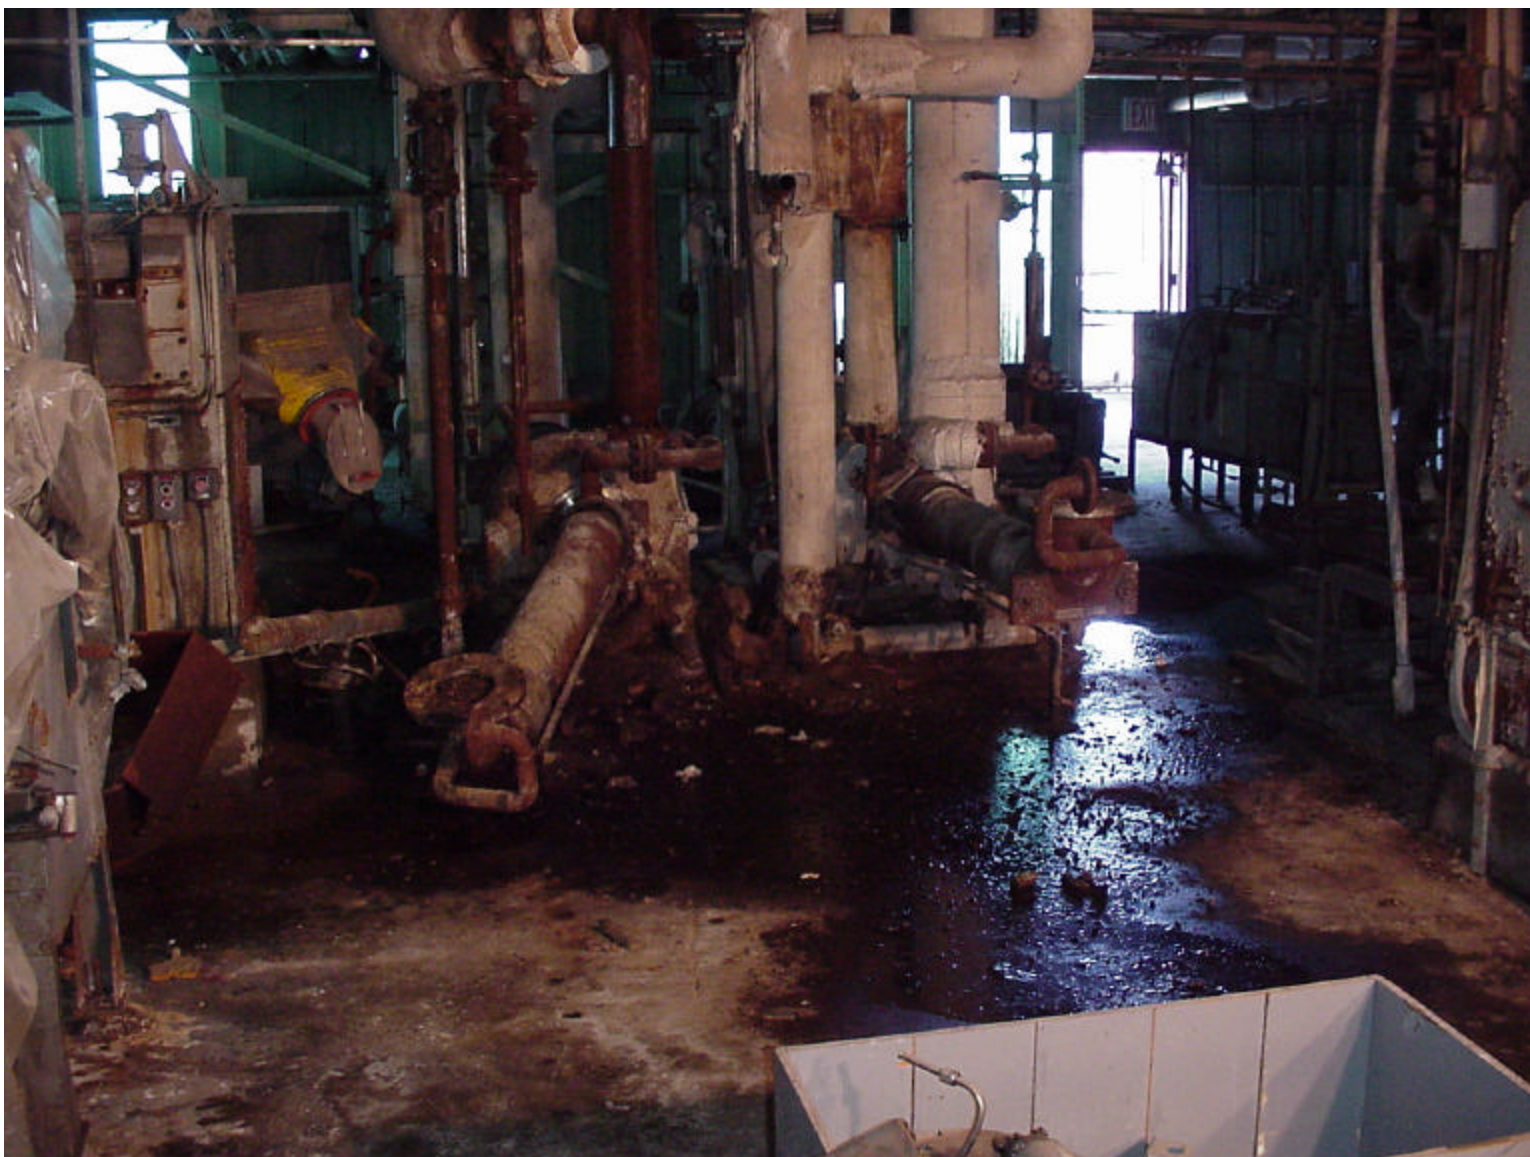
Photograph ID	Date Taken	Section #	Room #	Room Description	Description
MVC-175	11/18/99	I	1.05D	Polymer Plant 3rd Floor	Residual oil in southern portion of room.

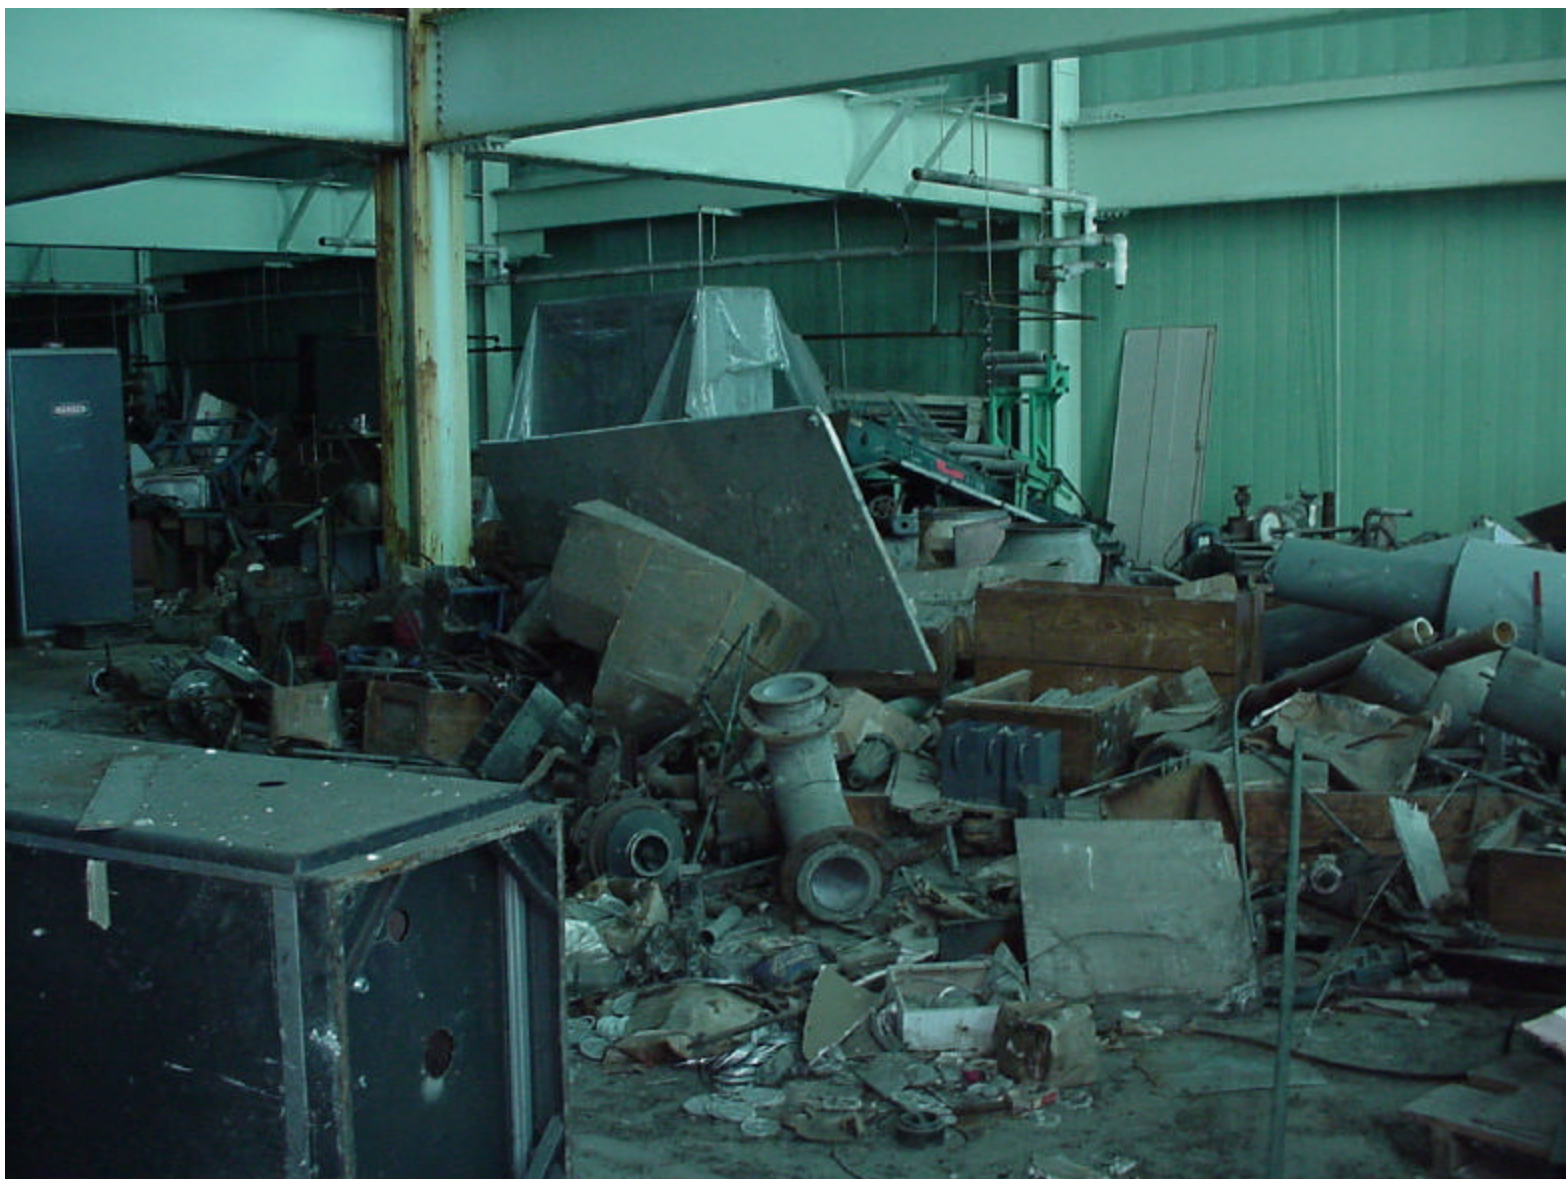
Photograph ID	Date Taken	Section #	Room #	Room Description	Description
MVC-176	11/18/99	I	1.05D	Polymer Plant 3rd Floor	Miscellaneous debris located throughout room.

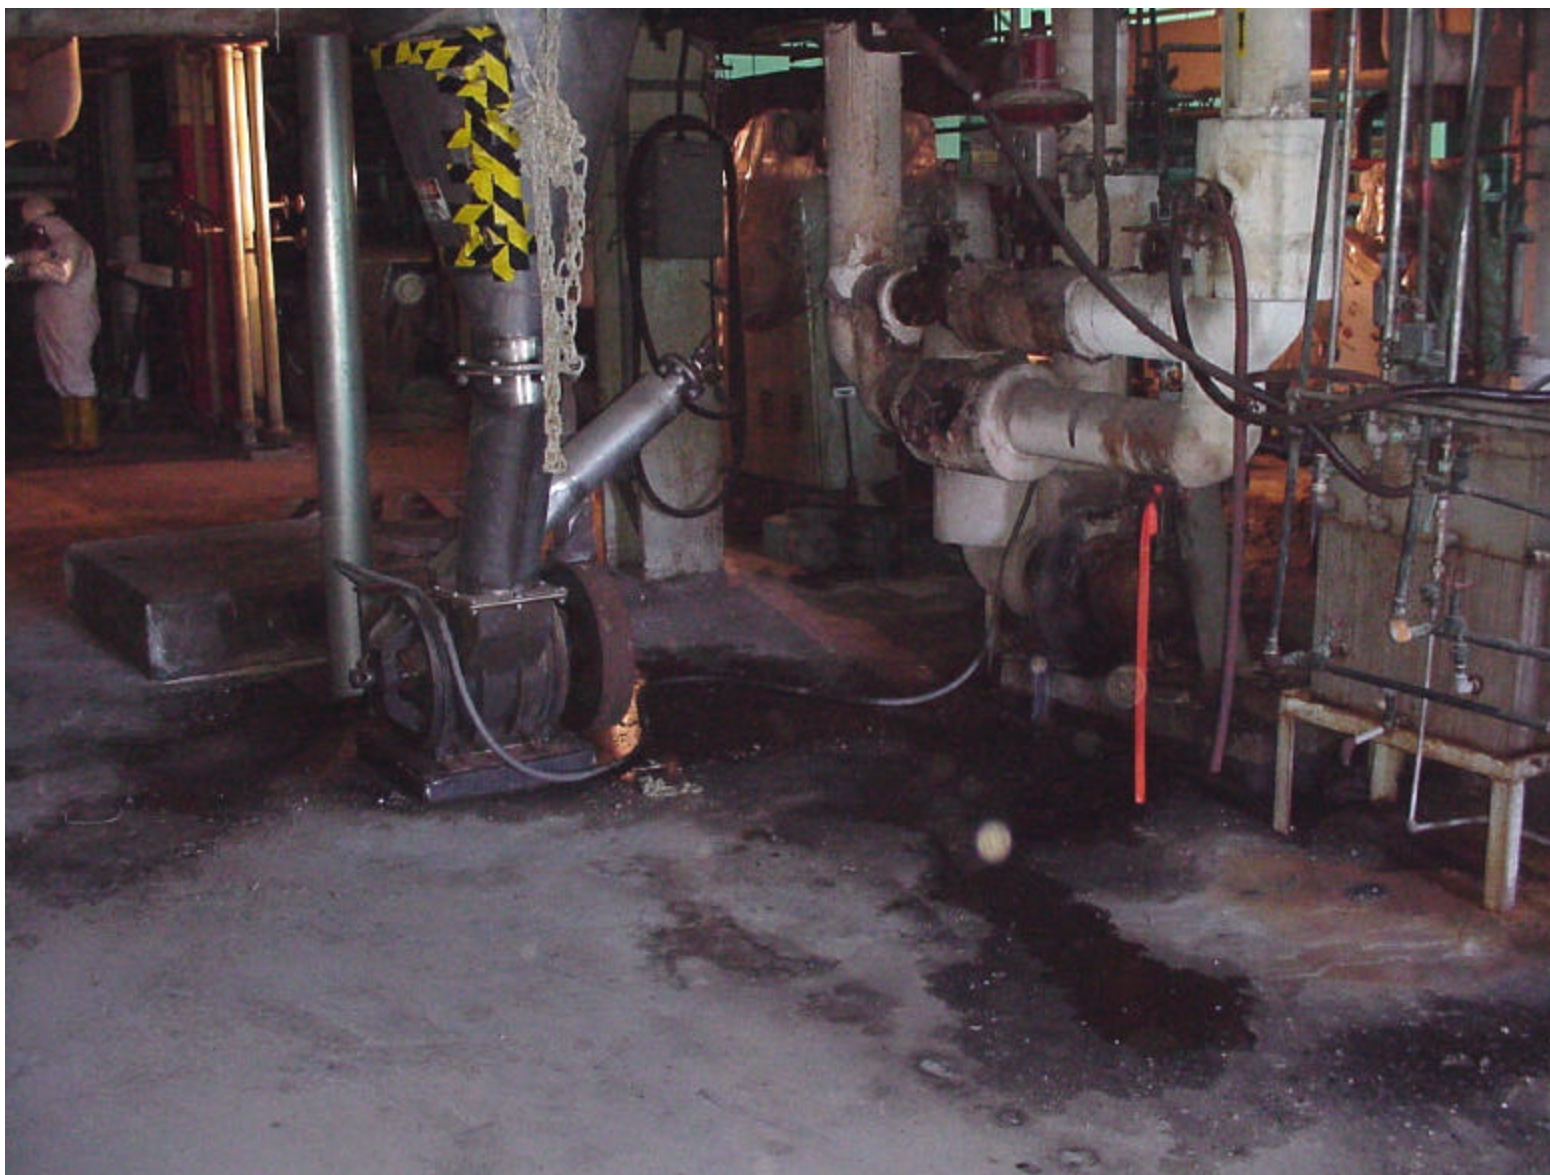
Photograph ID	Date Taken	Section #	Room #	Room Description	Description
MVC-177	11/18/99	I	1.05D	Polymer Plant 3rd Floor	Example of oil staining under equipment and throughout room.

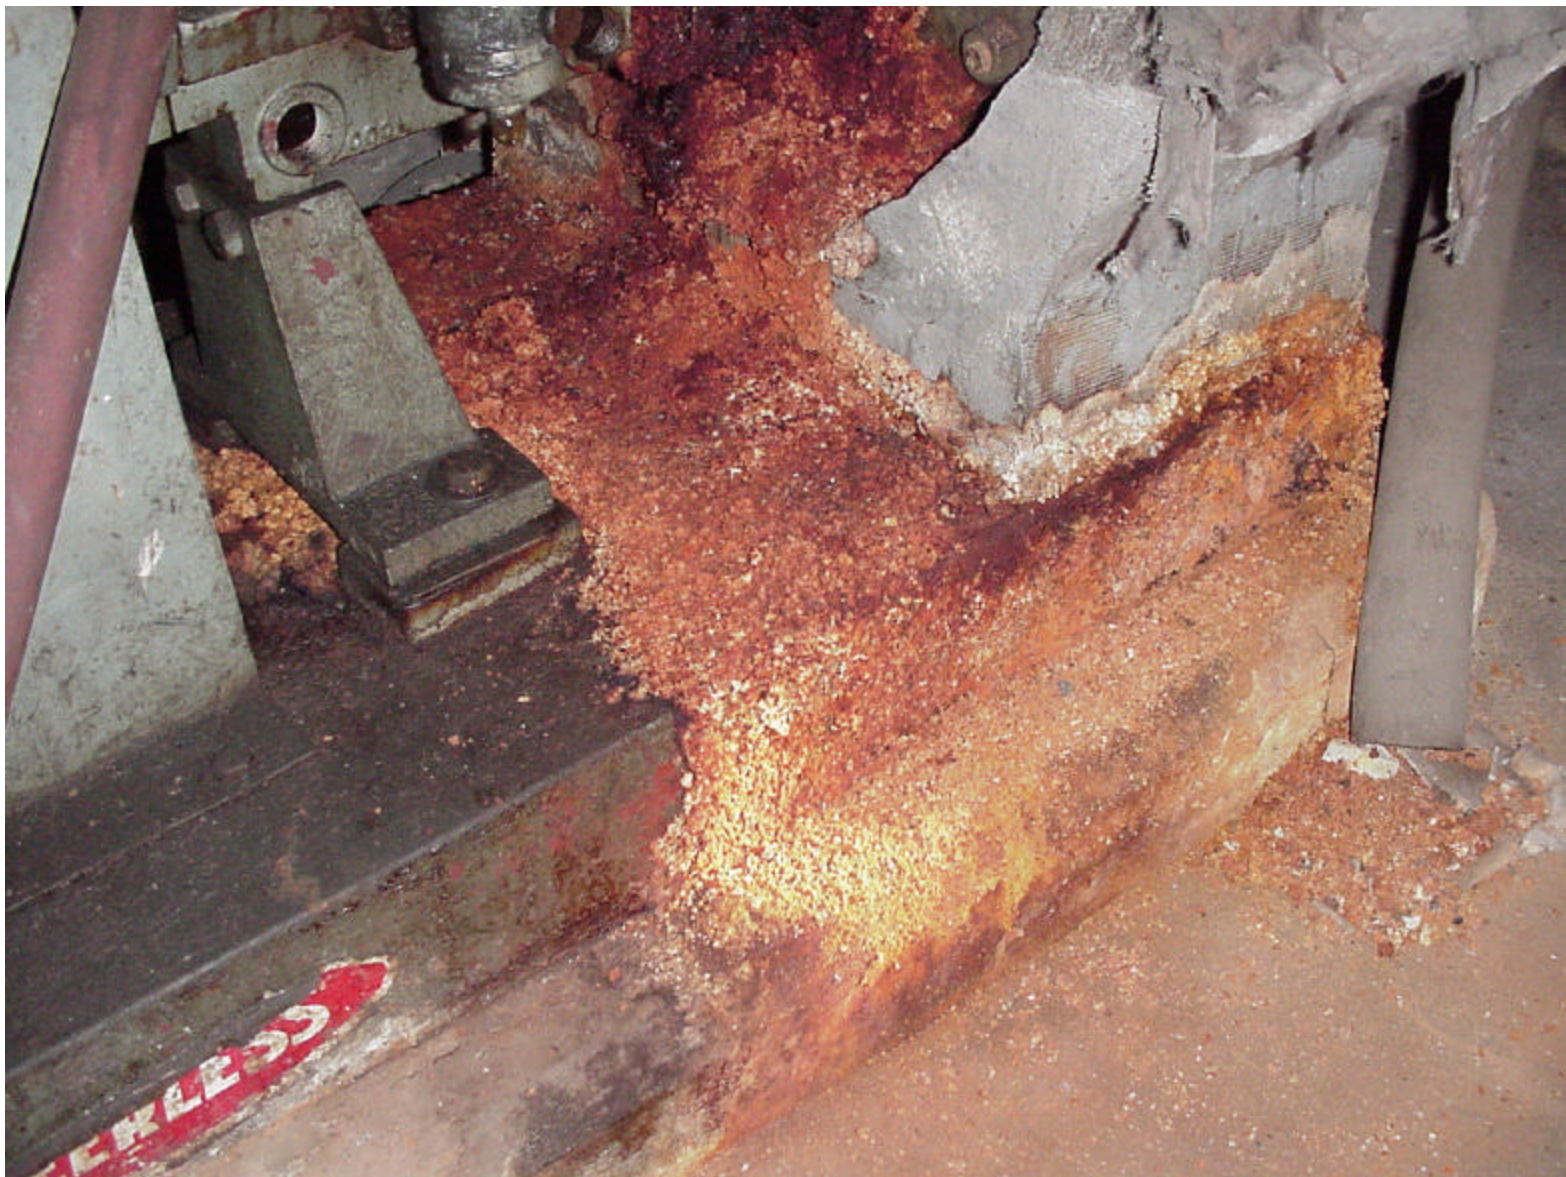
Photograph ID	Date Taken	Section #	Room #	Room Description	Description
MVC-178	11/18/99	I	1.05D	Polymer Plant 3rd Floor	Pump along west wall with unknown orange solid material on it.

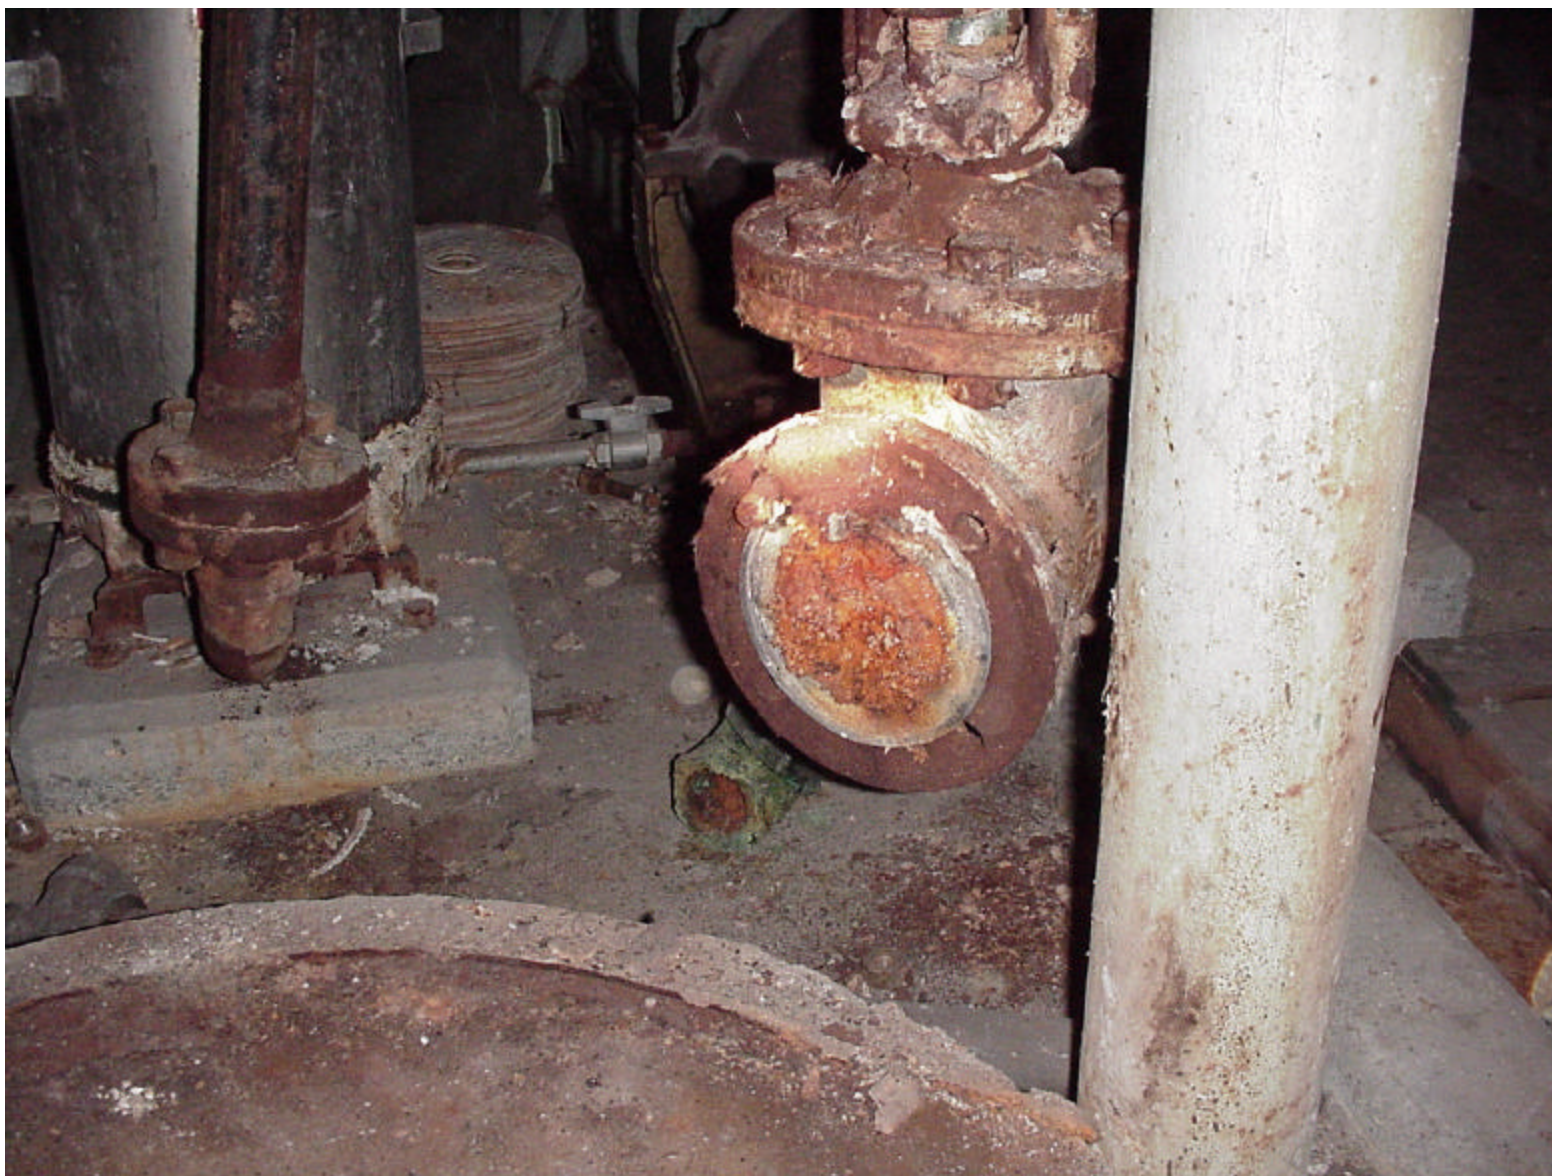
Photograph ID	Date Taken	Section #	Room #	Room Description	Description
MVC-179	11/18/99	I	1.05D	Polymer Plant 3rd Floor	Pipeline filled with unknown orange solid material

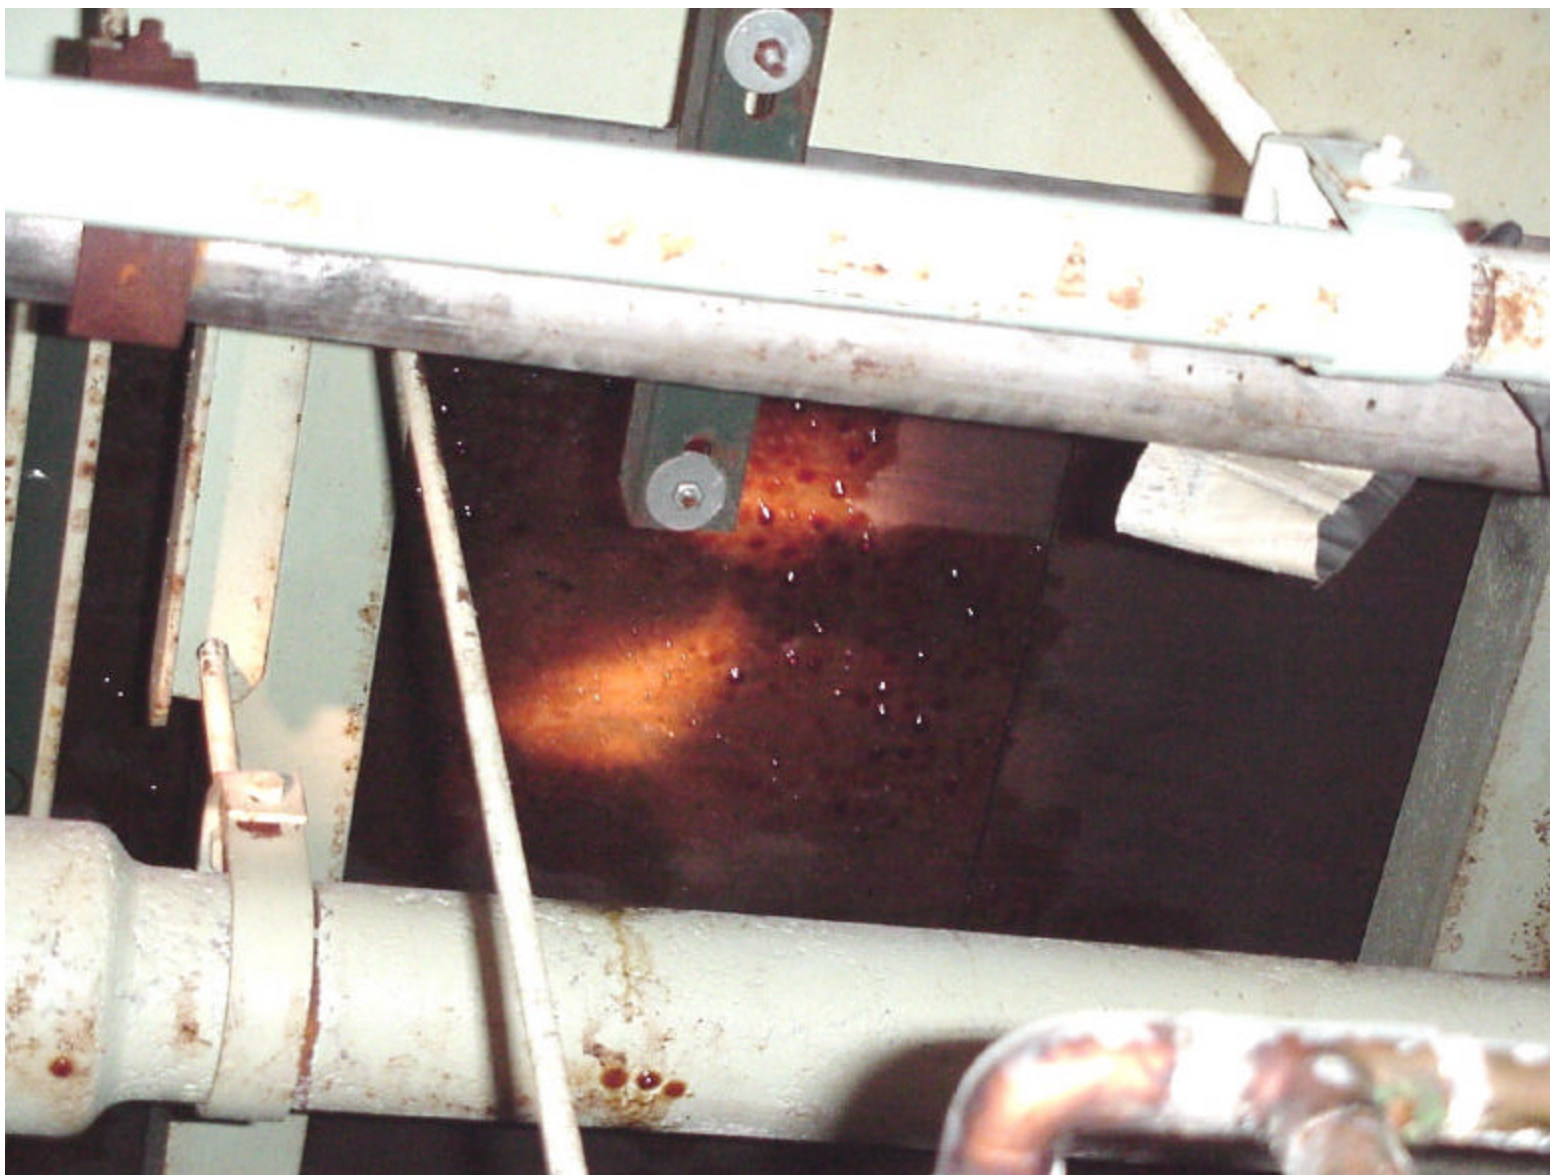
Photograph ID	Date Taken	Section #	Room #	Room Description	Description
MVC-180	11/18/99	I	1.05D	Polymer Plant 3rd Floor	Oil leaking through rooftop along west wall.

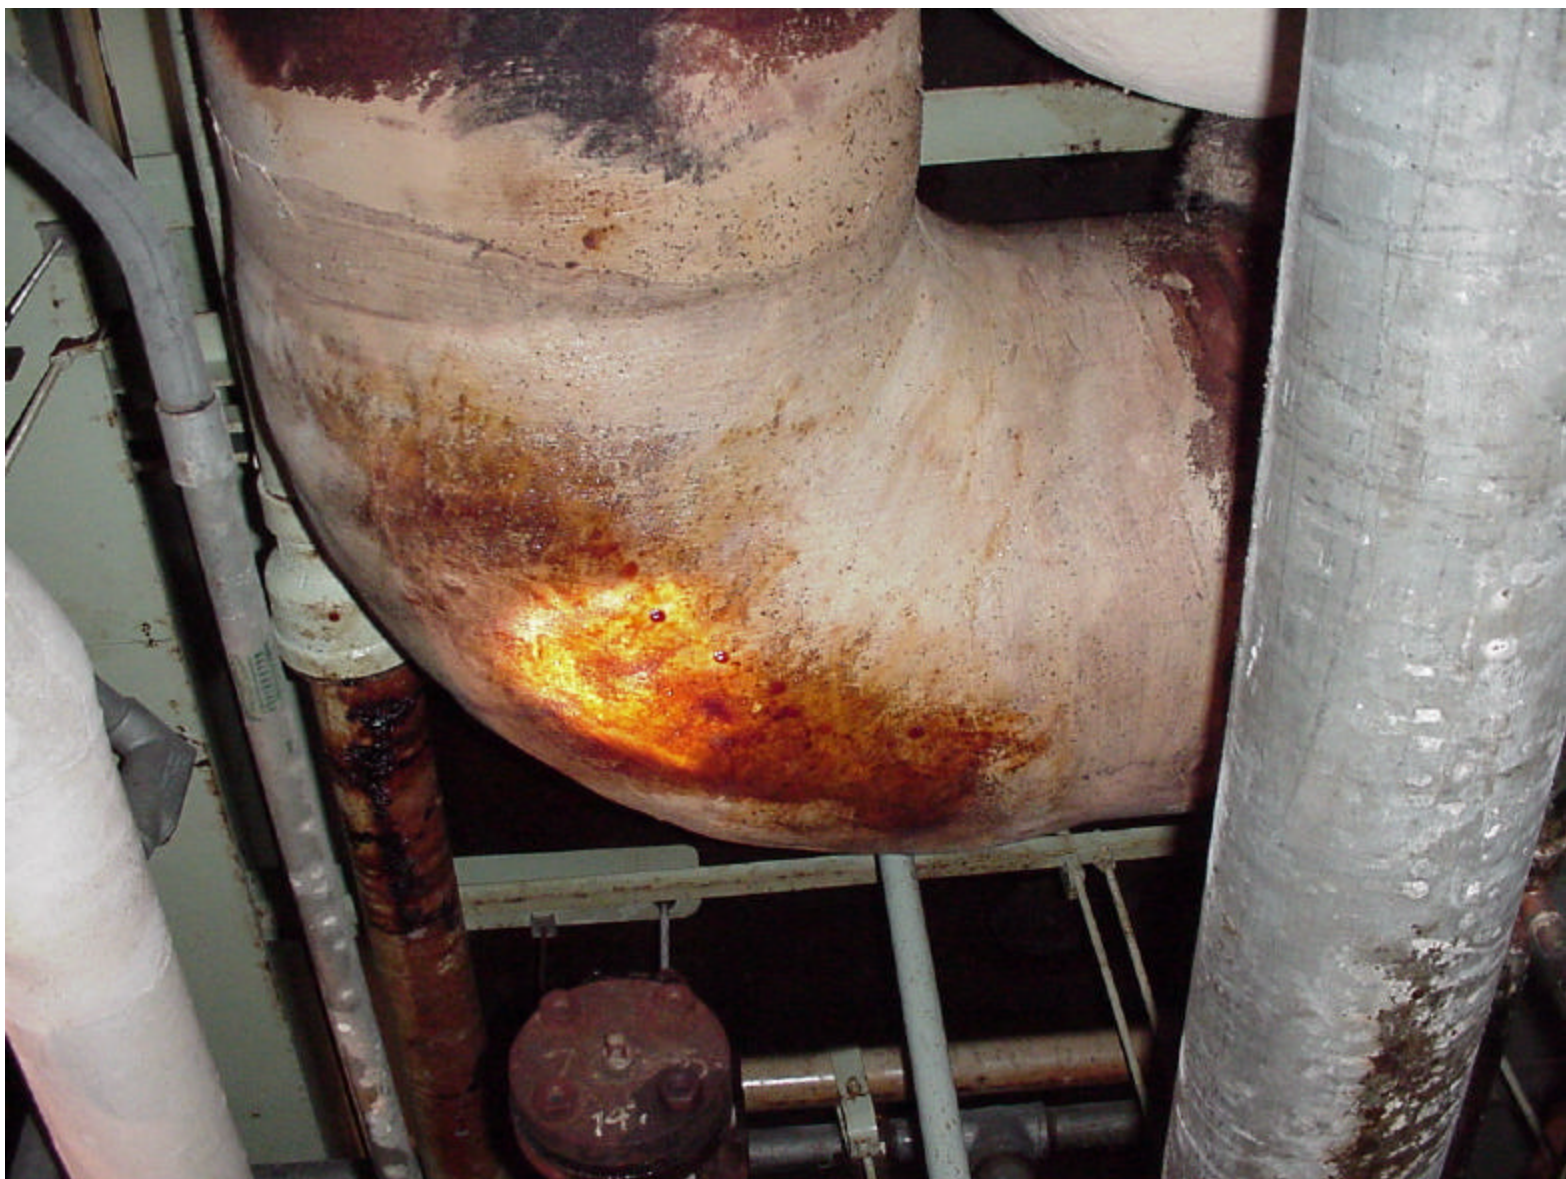
Photograph ID	Date Taken	Section #	Room #	Room Description	Description
MVC-181	11/18/99	I	1.05D	Polymer Plant 3rd Floor	Oil leaking through pipeline on ceiling of room.

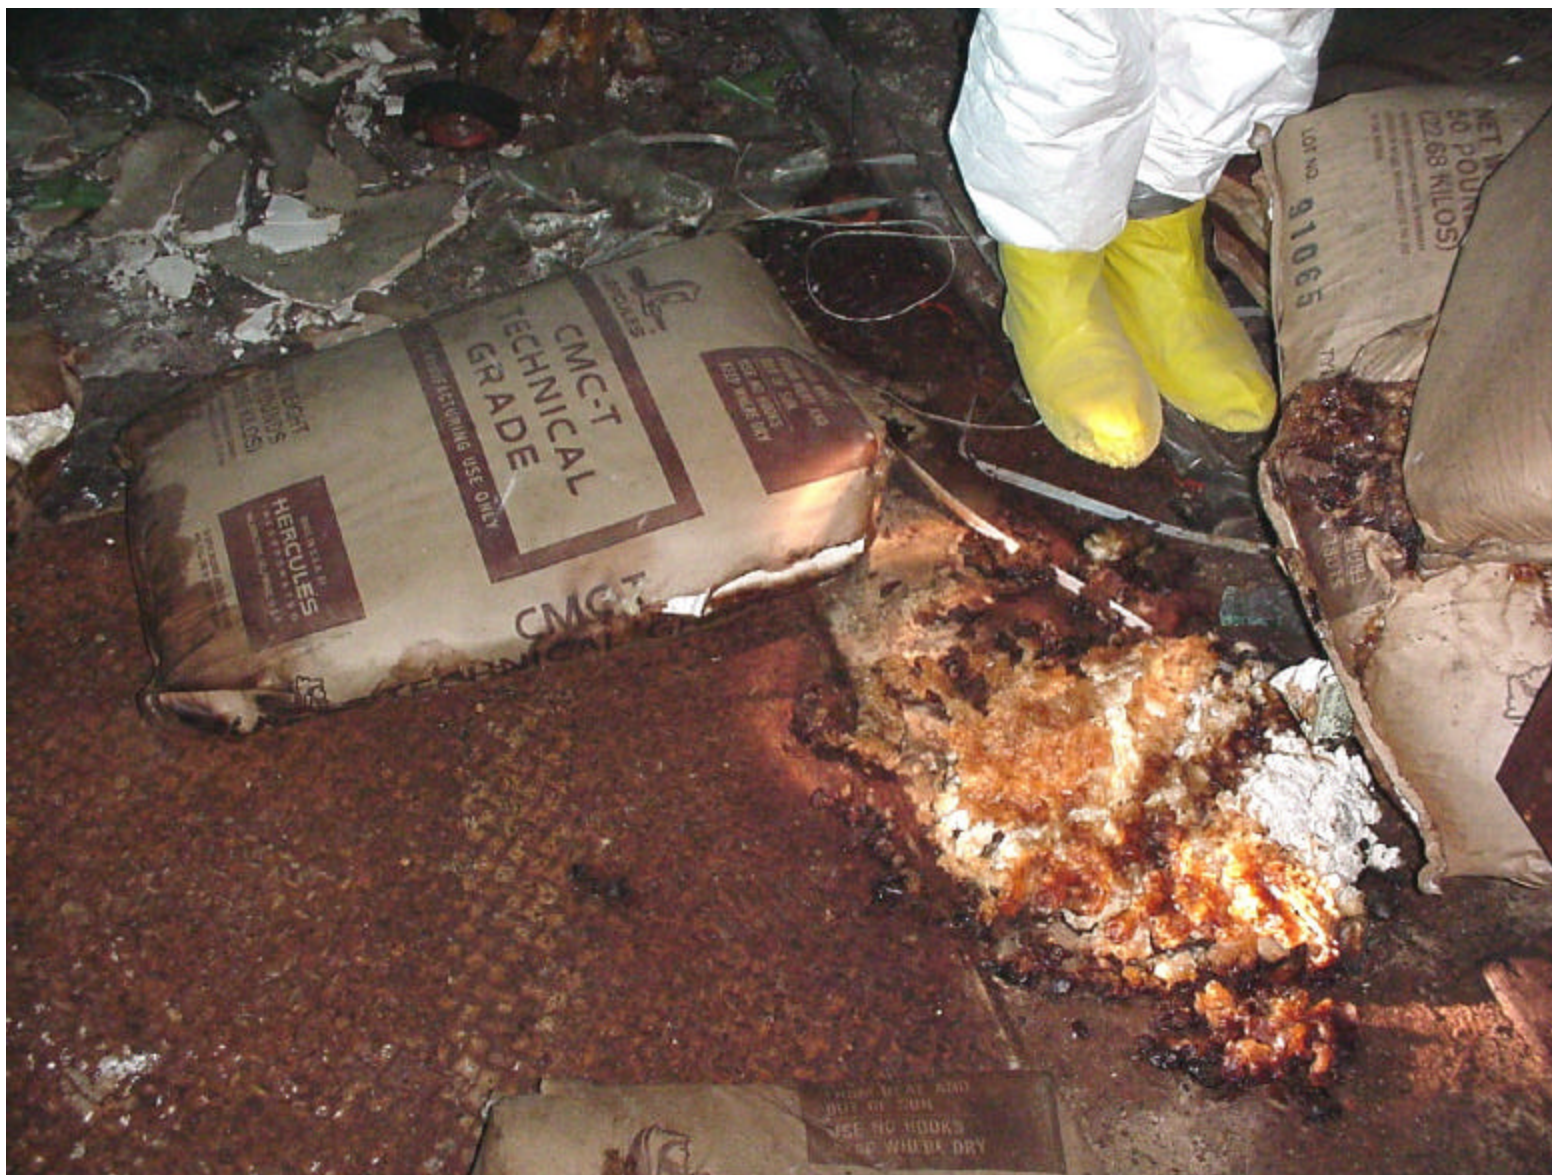
Photograph ID	Date Taken	Section #	Room #	Room Description	Description
MVC-183	11/18/99	I	1.05D	Polymer Plant 3rd Floor	Bags of solid chemical in northwest corner of room.

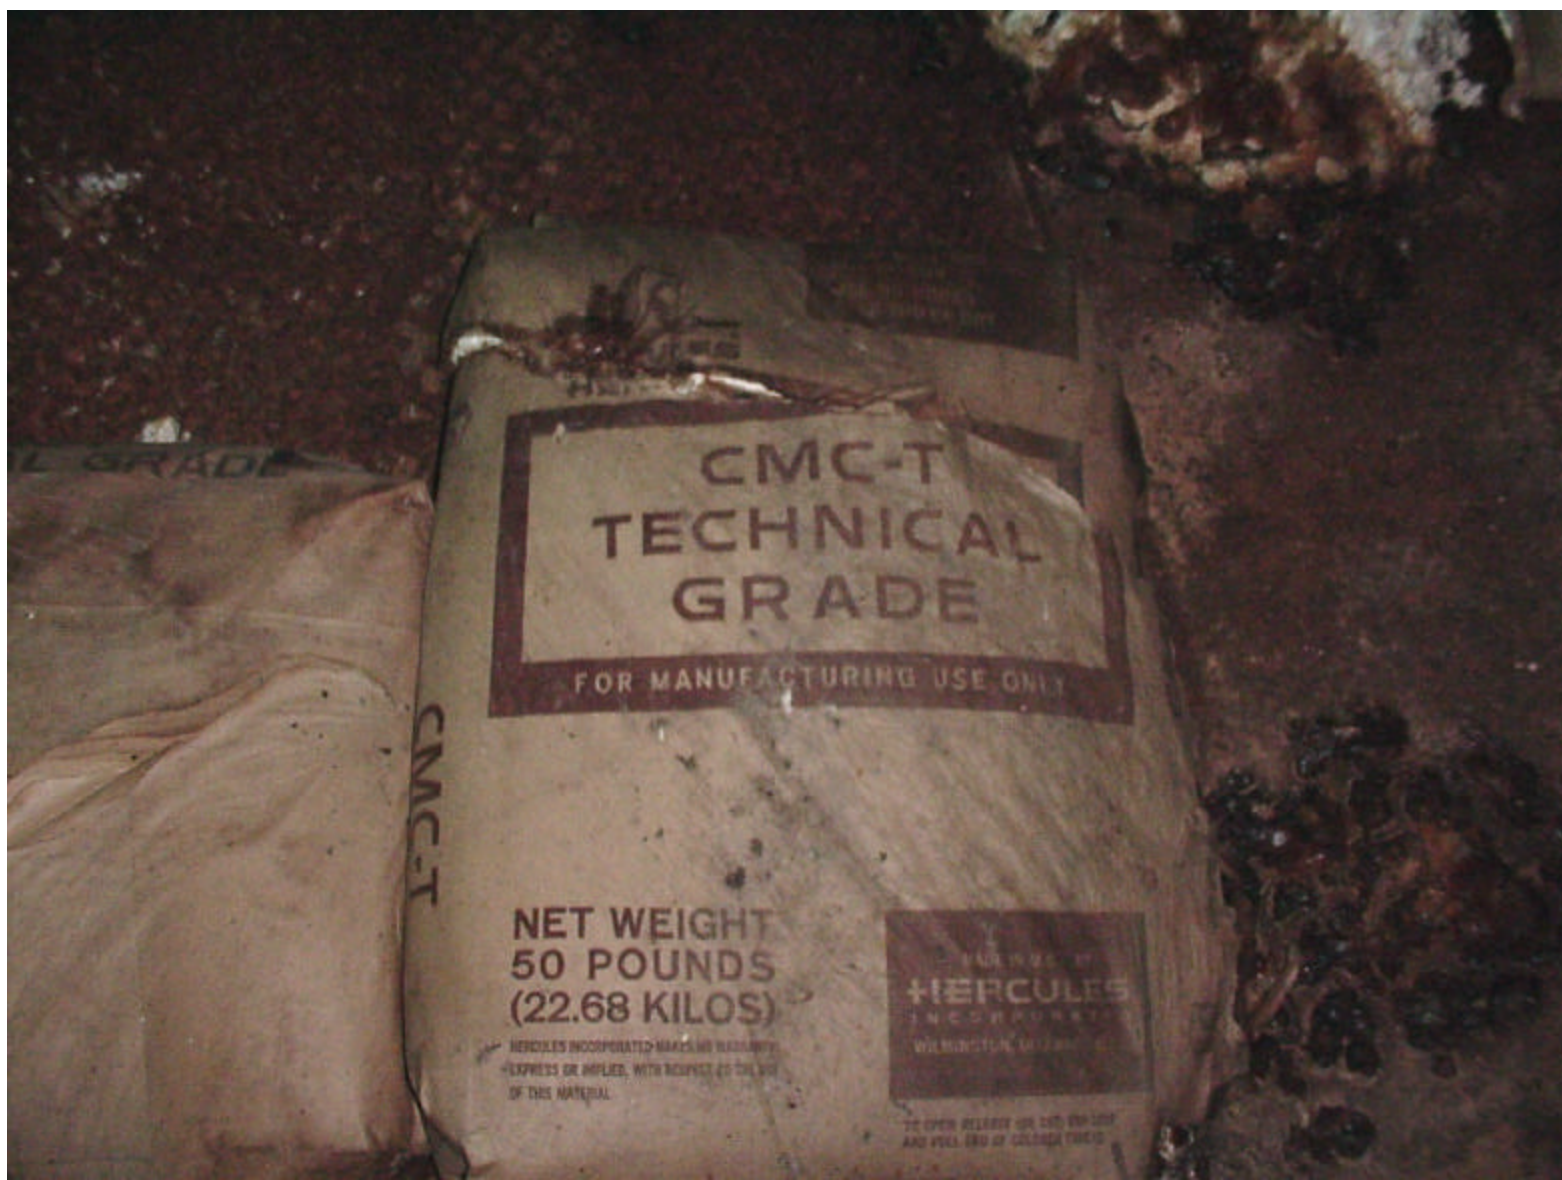
Photograph ID	Date Taken	Section #	Room #	Room Description	Description
MVC-184	11/18/99	I	1.05D	Polymer Plant 3rd Floor	Bags of solid chemical in northwest corner of room. (2nd photo)

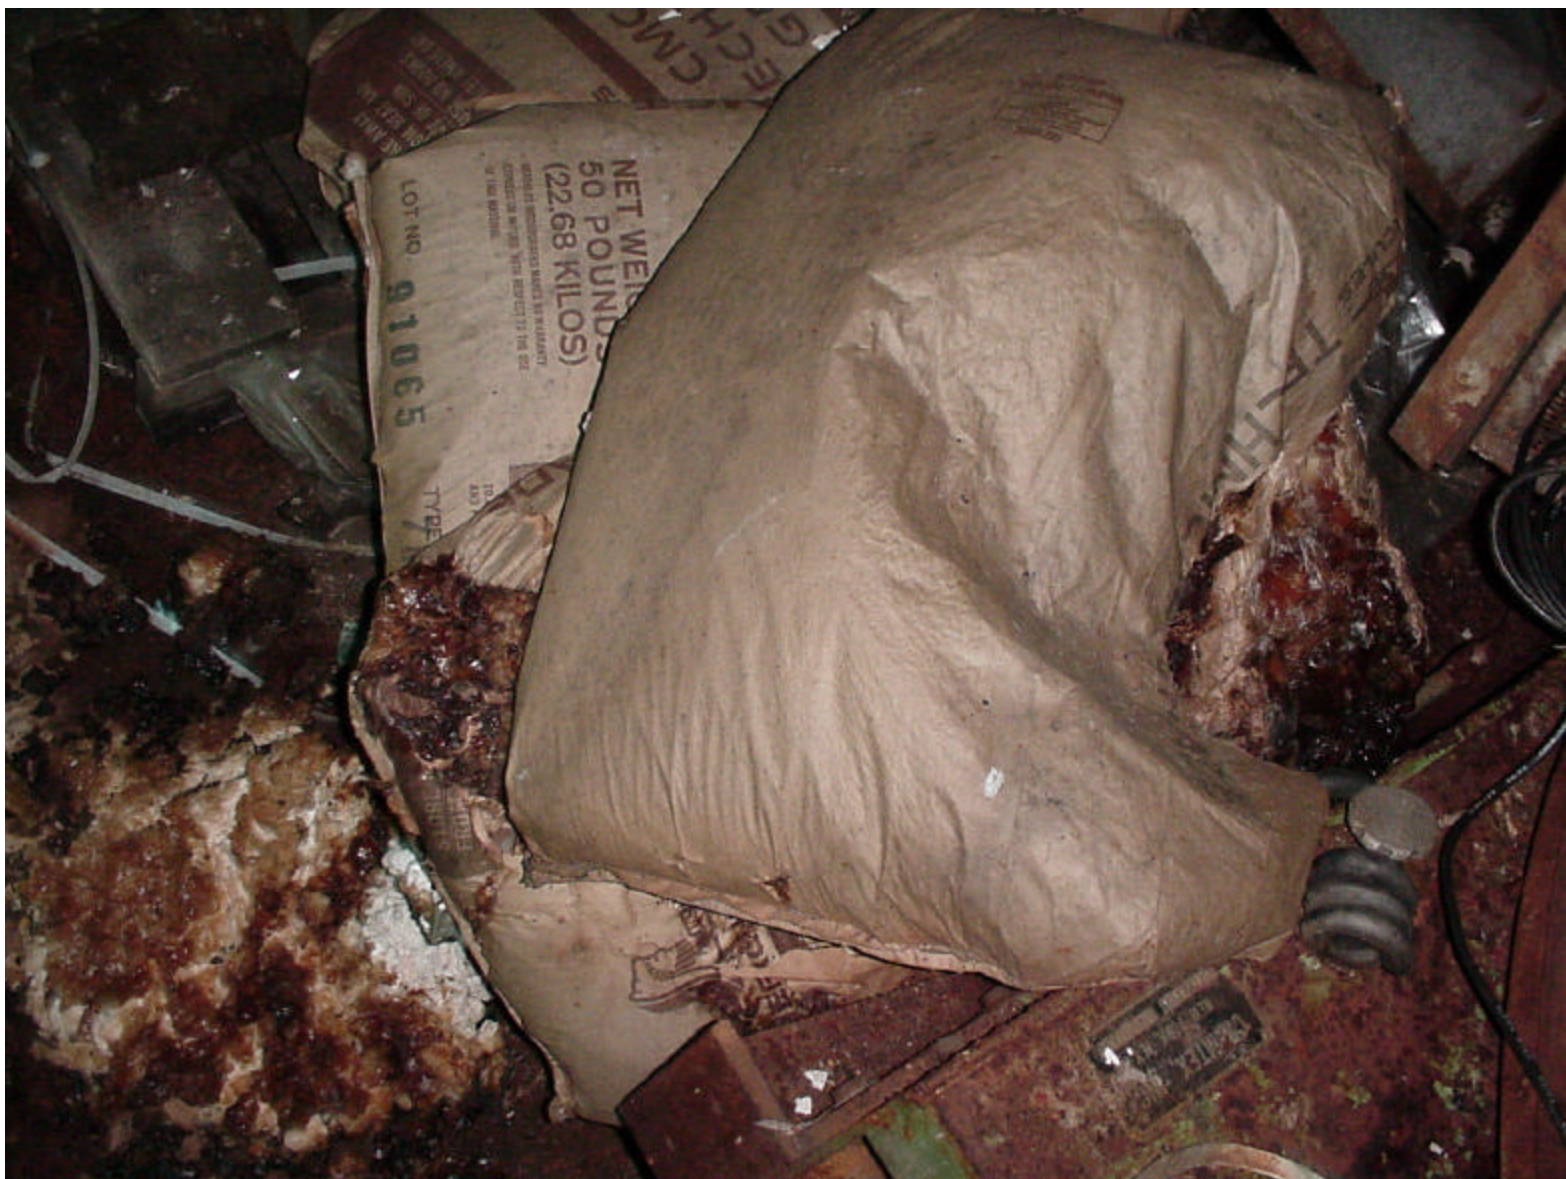
Photograph ID	Date Taken	Section #	Room #	Room Description	Description
MVC-185	11/18/99	I	1.05D	Polymer Plant 3rd Floor	Bags of solid chemical in northwest corner of room. (3rd photo)
